MASSIVE RAINSTORM GIVES RISE TO ENHANCED EMERGENCY RESPONSE PROTOCOLS FOR SUNNYBROOK

Unusually heavy summer rain and over two dozen flooding incident calls prompted swift action and changes to emergency response protocol at Toronto's Sunnybrook Health Sciences Centre.

CCGHC-RP-08E, March 24, 2017

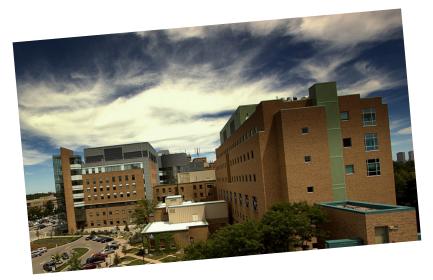
When a massive rainstorm hit Toronto on the evening of July 8, 2013, over two dozen building leaks were reported at Sunnybrook Health Sciences Centre. Teams worked throughout the night to pump out the water and prevent further damage.

In response to the findings, Sunnybrook has now strategically placed 14 mobile spill response kits throughout basement corridors and large yellow signage posted on doors clearly indicates the locations of all kits.

Plant Operation & Maintenance Department employees have also increased the frequency of preventive cleaning and inspections for all storm drain catch basins on the campus.

On a much broader scale, the hospital has also completed further building envelope upgrades including roofing membranes, foundations and drainage improvements to help reduce the potential for future water penetration incidents such as those that wreaked havoc the evening of July 8th, 2013.
